DC Motor Maintenance - Undercutting

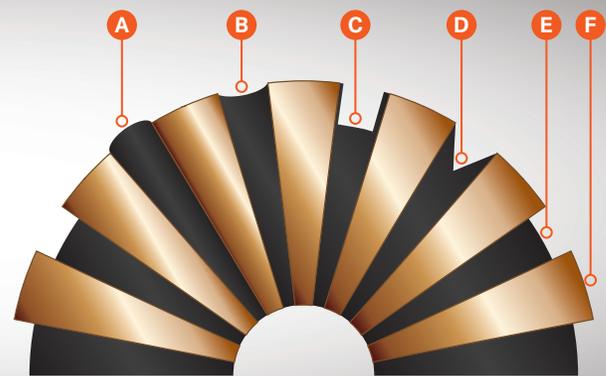
Top view of commutator

The diagram on the right shows a few different conditions that may be seen in the commutator.

- A** Exposed mica "bump" due to wear of the surrounding commutator bars.
- B C D** Examples of improperly undercut mica.
- E** Correct undercut mica with a depth of 0.050" below the top of the commutator bar surface.
- F** Top of commutator bar.
